Manhole Inspection Summary

Manhole # S13II1038MH

Location Address: **4443 PALL MALL RD**

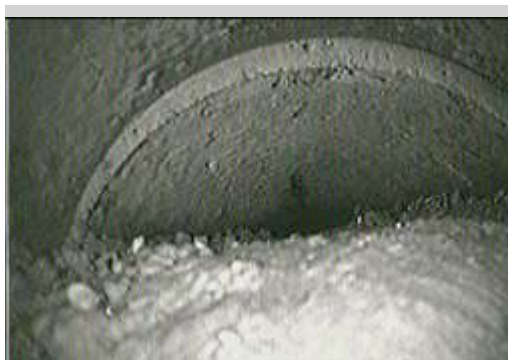
Inside of I6

Evidence of surcharge - Bench debris.
Corroded step.

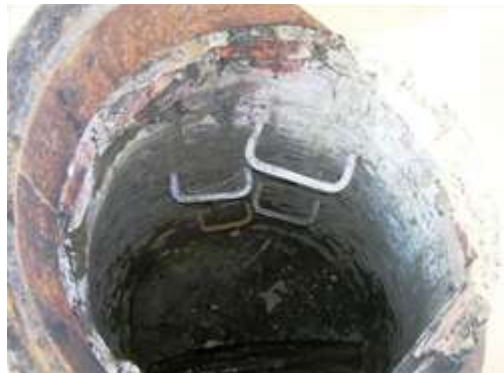
Defect

Frame leaks. Adjustment loose brick,
deterioration, and infiltration. Barrel
infiltration - other side.

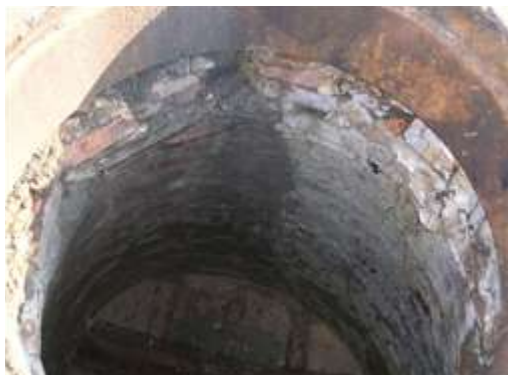
Defect

Frame leaks. Adjustment loose brick,
deterioration, and infiltration. Barrel
infiltration.

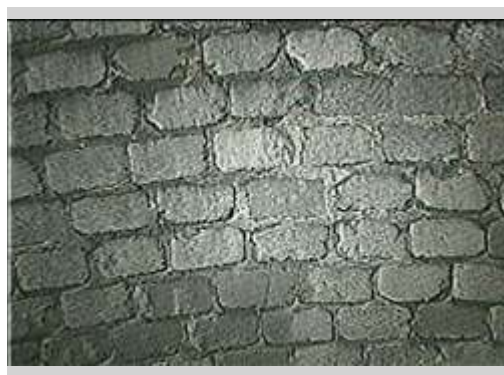
Defect

Barrel deterioration and infiltration.

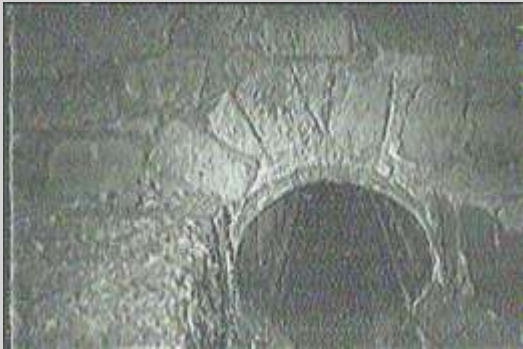
8 in. Circular Gravity Sewer Pipe Out @ 12 O'Clock

Infiltration: **Evidence** Pipe Seal Cond: **Unknown**
